Experimental Study MR 97-04

**Evaluation of Dowel Bar Retrofit  
Using Minnesota Specified 3U18 Patch Mix**

**Final Report**

Project IM-8-029(006)000

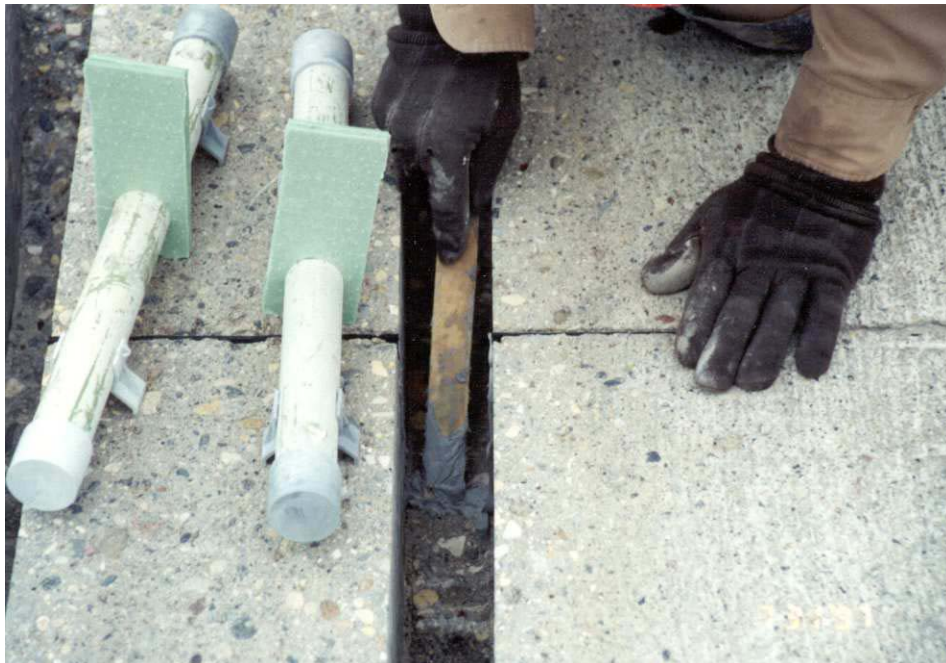
After the sand blasting process was completed, a mechanical caulking dispenser was used to seal the existing transverse joint crack at the bottom and sides of the slot. Photo 3 Illustrates caulking being worked outward approximately 1/2" from the existing joint.

**Photo 3 - View of caulking process.**

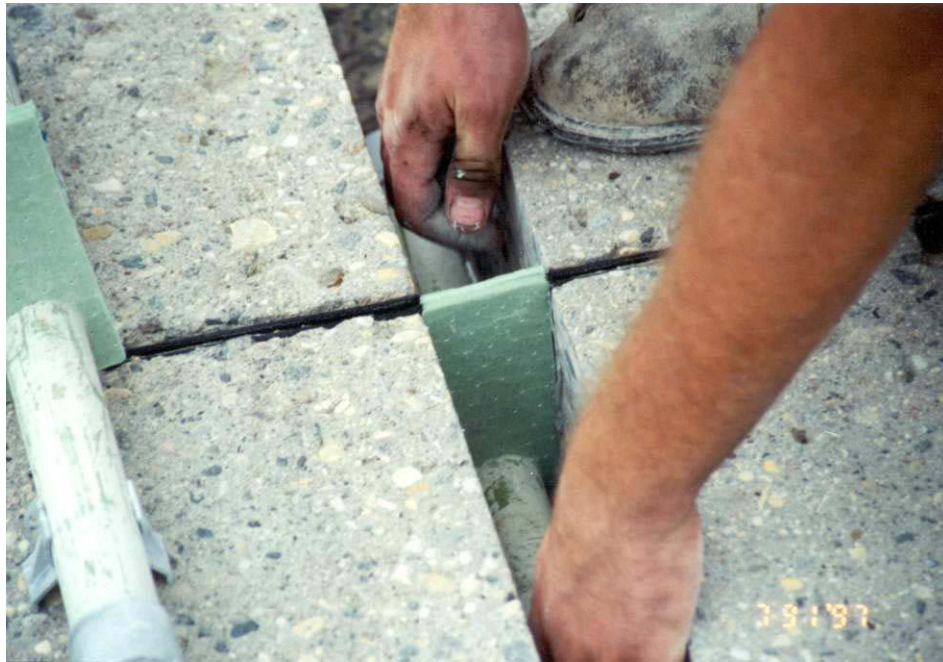
Photo 6 shows the installed dowel bar and core board. Note the two 1/4" core boards that are glued together.

**Photo 6 - View of the dowel bar and core board installed in the slot prior to the mix being placed.**

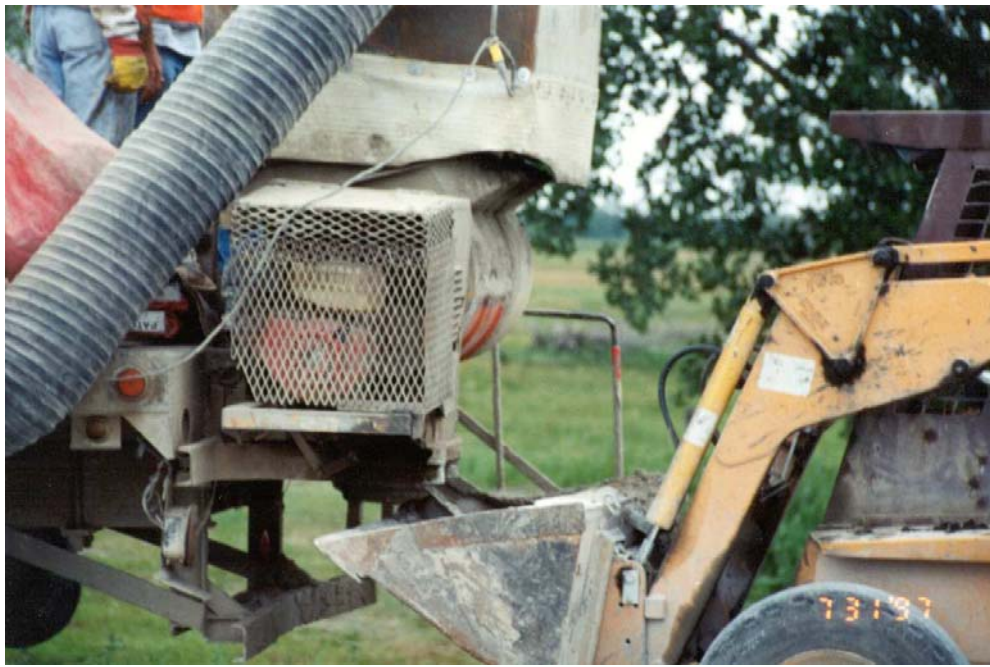
Photo 7 on the next page shows a partial view of the batch mix unit on the left side of the picture. The contractor continuously batched small amounts of patch mix as the process went on. The contractor commented that he preferred using a batch mix unit as opposed to a mobile mixer unit because better control and consistency of the mix could be achieved. Prior to placement of the 3U18 patch mix, tests were performed for air, slump, and temperature. Cylinders were also taken of the mix. Several mixes had to be batched to obtain the desired air.

**Photo 7 - View of the batch mix unit used to batch the 3U18 patch mix.**

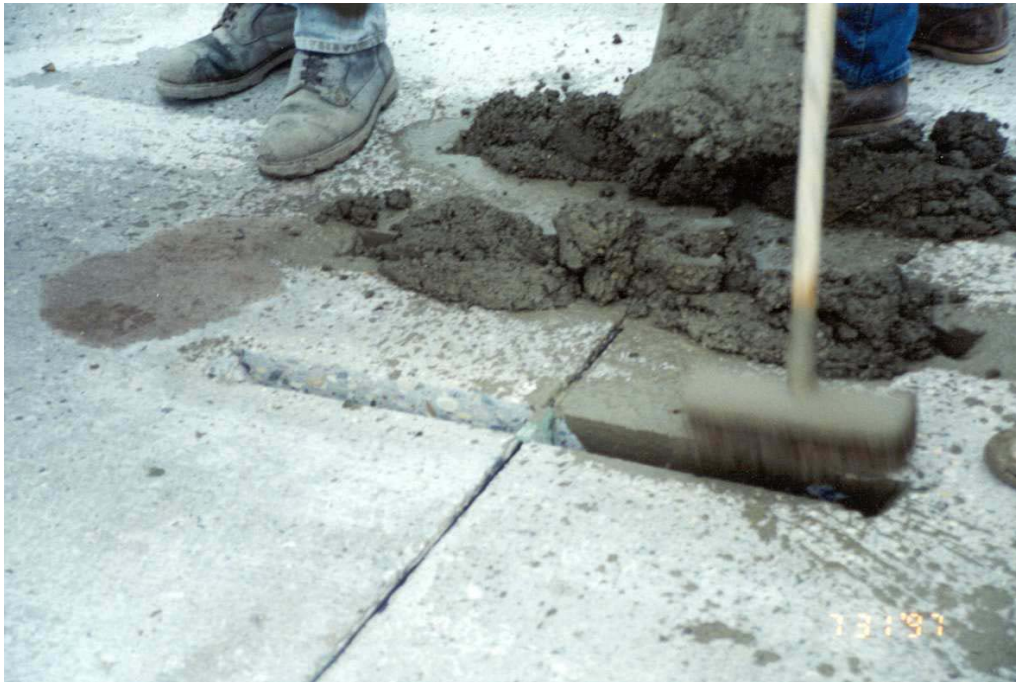
As previously mentioned, the existing concrete grout served as an absorbing agent to fill any empty pore spaces in the existing concrete. The contractor believed it would reduce the chance for shrinkage cracks. Care was taken to apply the grout just before the placing of the patch mix. Photo 9 illustrates the grout composed of sand, water, and cement being broomed into the slot prior to placing the 3U18 patch mix.

**Photo 9 - View of the grout being applied to the dowel bar retrofit slot.**

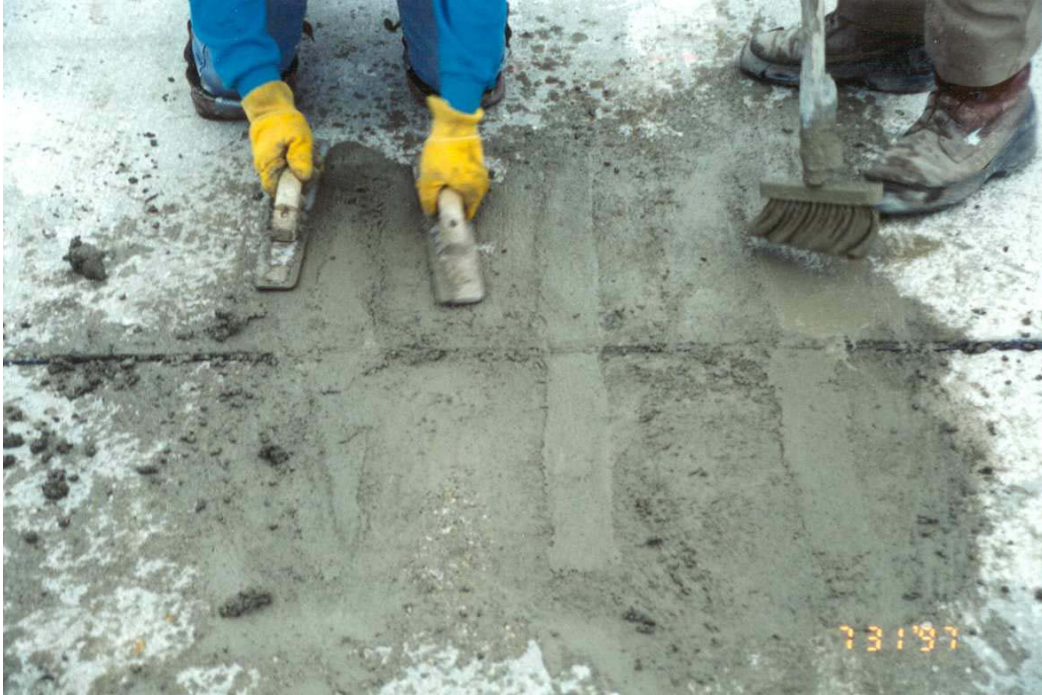
Photo 11 shows grout being applied just after the patch mix was finished. The contractor commented that placing the grout on the edge between the new mix and the existing concrete would also reduce the chance of shrinkage cracks.

**Photo 11 - View of the grout being applied to a finished 3U18 patch mix.**

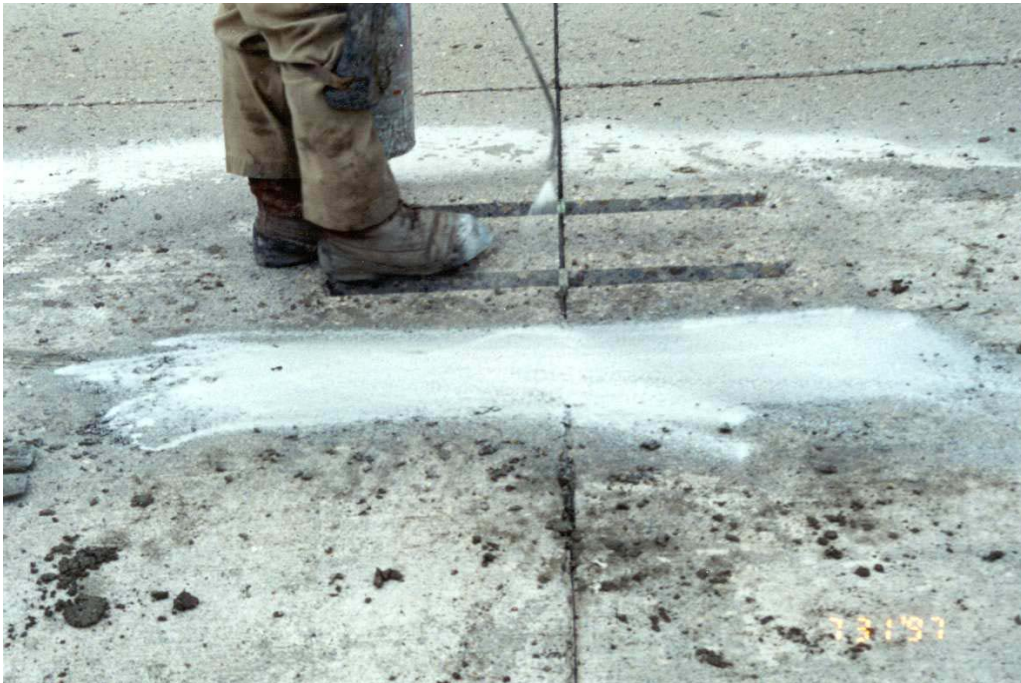
Photo 12 shows the curing compound being applied to a finished slot. The contractor believed very strongly that the oil-based cure used here will do more to aid in reducing the chance for shrinkage cracks than a water-based cure.

**Photo 12 - View of the oil based curing compound being applied to the finished and grouted 3U18 patch mix.**
